Manhole Inspection Summary

Manhole # S23WW1015MH

Insp Date: **2/21/07 2:40 PM**

Location Address: **11 ELMWOOD RD**

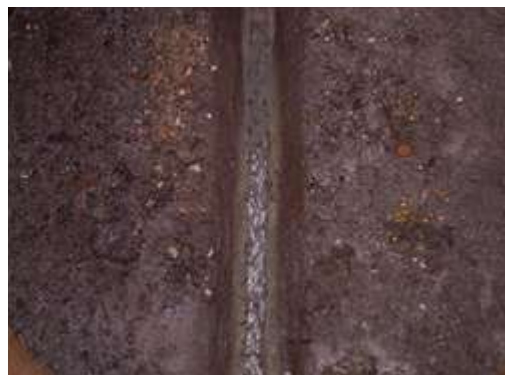
Top View

Bench ☒ Exists Material: **Brick** ☐ Parged ☒ **Debris** (not Condition related)

Bench debris.

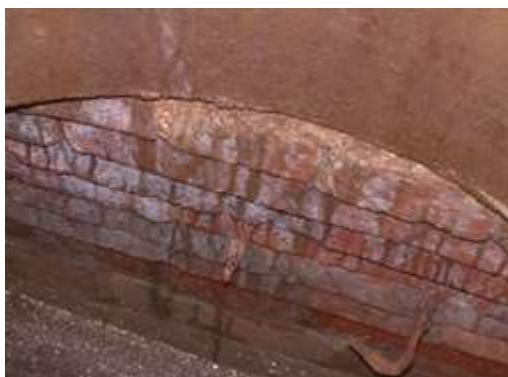
Defect

Infiltration: ☐ None ☒ **Joint** ☐ Cracks ☒ **Mortar** ☐ Roots ☐ Wall

Frame leaks. Corbel infiltration.

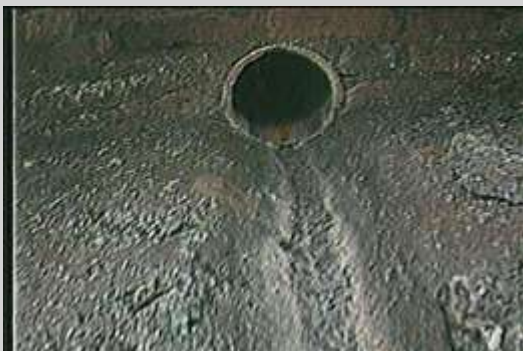
6 in. Circular Gravity Sewer Pipe In @ 6 O'Clock

Condition: ☐ Sound ☐ Cracked ☐ Root Intrusion ☐ Loose Brick ☒ **Deteriorated**

Infiltration: ☐ None ☐ Joint ☐ Cracks ☒ **Mortar** ☐ Roots ☒ **Wall**

Barrel deterioration and infiltration.

Infiltration: **None** Pipe Seal Cond: **Cracked**
